A NATURAL SCIENTIFIC CAUSE OF FIRE

AS THIS CASE ILLUSTRATES, SOMETIMES AN
INVESTIGATOR'S BEST ASSETS ARE **COMMON SENSE,**
SIMPLE OBSERVATION AND OUT-OF-THE-BOX THINKING.

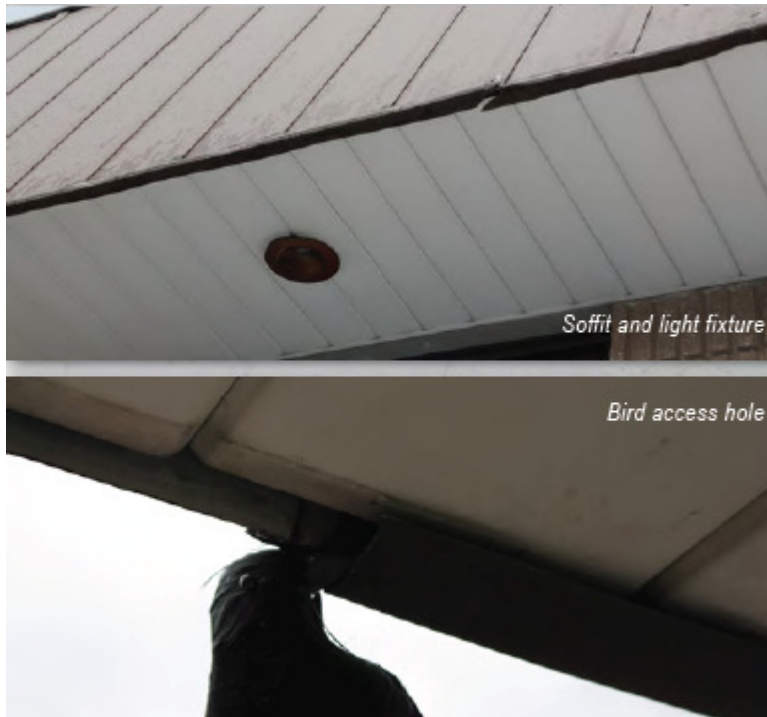
Fire Scene

A careful examination and detailed inspection of the building revealed that the fire, in fact, originated within the concealed area above the first floor location. There was no total access to this area under normal circumstances (pre-fire). However, in this case, due to the fire damage, I was able to evaluate and inspect all potential ignition sources that could be responsible for the cause of the fire and ultimately the propagation and damage.

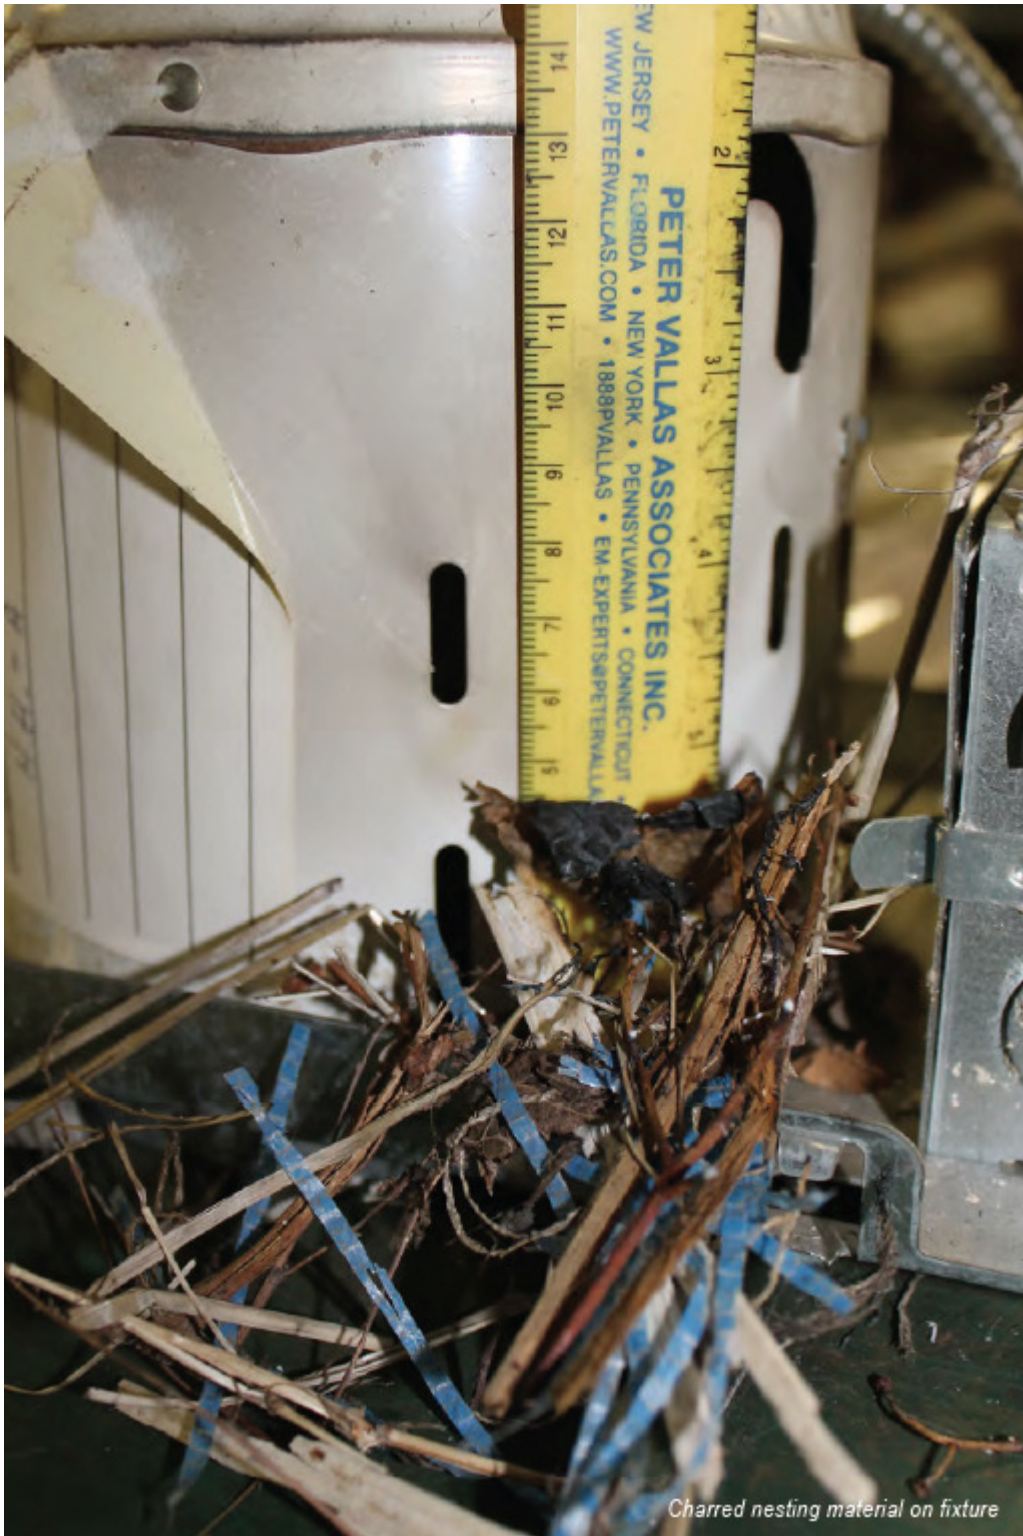
Charred nesting material on fixture

Typically dry grass and fire tinder will dry quickly because of high exposure to wind; this makes them ideal for fire making. The bundling and the dried goods, grass and twigs were further dried out through contact to the light fixtures. This resulted in ignition and open flame causing the incipient stage of the fire.

Immediately after realizing that here was the likely answer to what had been eluding my investigative team and me, I contacted my client, who conferenced the chain's corporate engineers, who proceeded to perform an invasive inspection of the soffit. Upon inspection at least two bundled nests were found adjacent to the recessed or high-hat lighting fixtures and, in one case, there was evidence of slight char to the dried bundled material.

In closing, the corporate engineers for “Burger Patty House” had immediately notified all of their restaurants of similar design to inspect, remove and redesign the soffits to eliminate this potential exposure and risk to the restaurants, employees and customers.
