A NATURAL SCIENTIFIC CAUSE OF FIRE

AS THIS CASE ILLUSTRATES, SOMETIMES AN
INVESTIGATOR'S BEST ASSETS ARE **COMMON SENSE,**
SIMPLE OBSERVATION AND OUT-OF-THE-BOX THINKING.

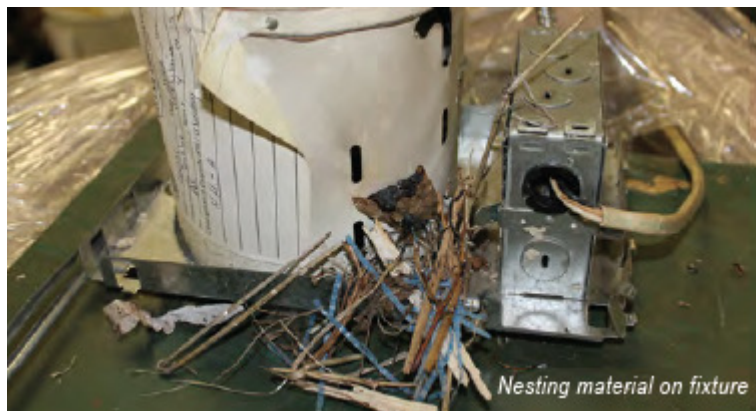
In some cases I am not able to make a determination as to the cause of a fire. Severe building damage due to the fire or even fire suppression efforts can result in damage beyond recognition. After the extensive and detailed inspection of this fire scene, I reported to my client, the insurance company for the structure and the corporation as well as the chain's corporate engineers, that I was unable to render an opinion or conclusively determine the origin and cause of this fire.
